CATANDUANES

SHEET 3862-III

FLOOD HAZARD MAP OF PANDAN QUADRANGLE

LIQUEFACTION POTENTIAL MAP OF PANDAN QUADRANGLE

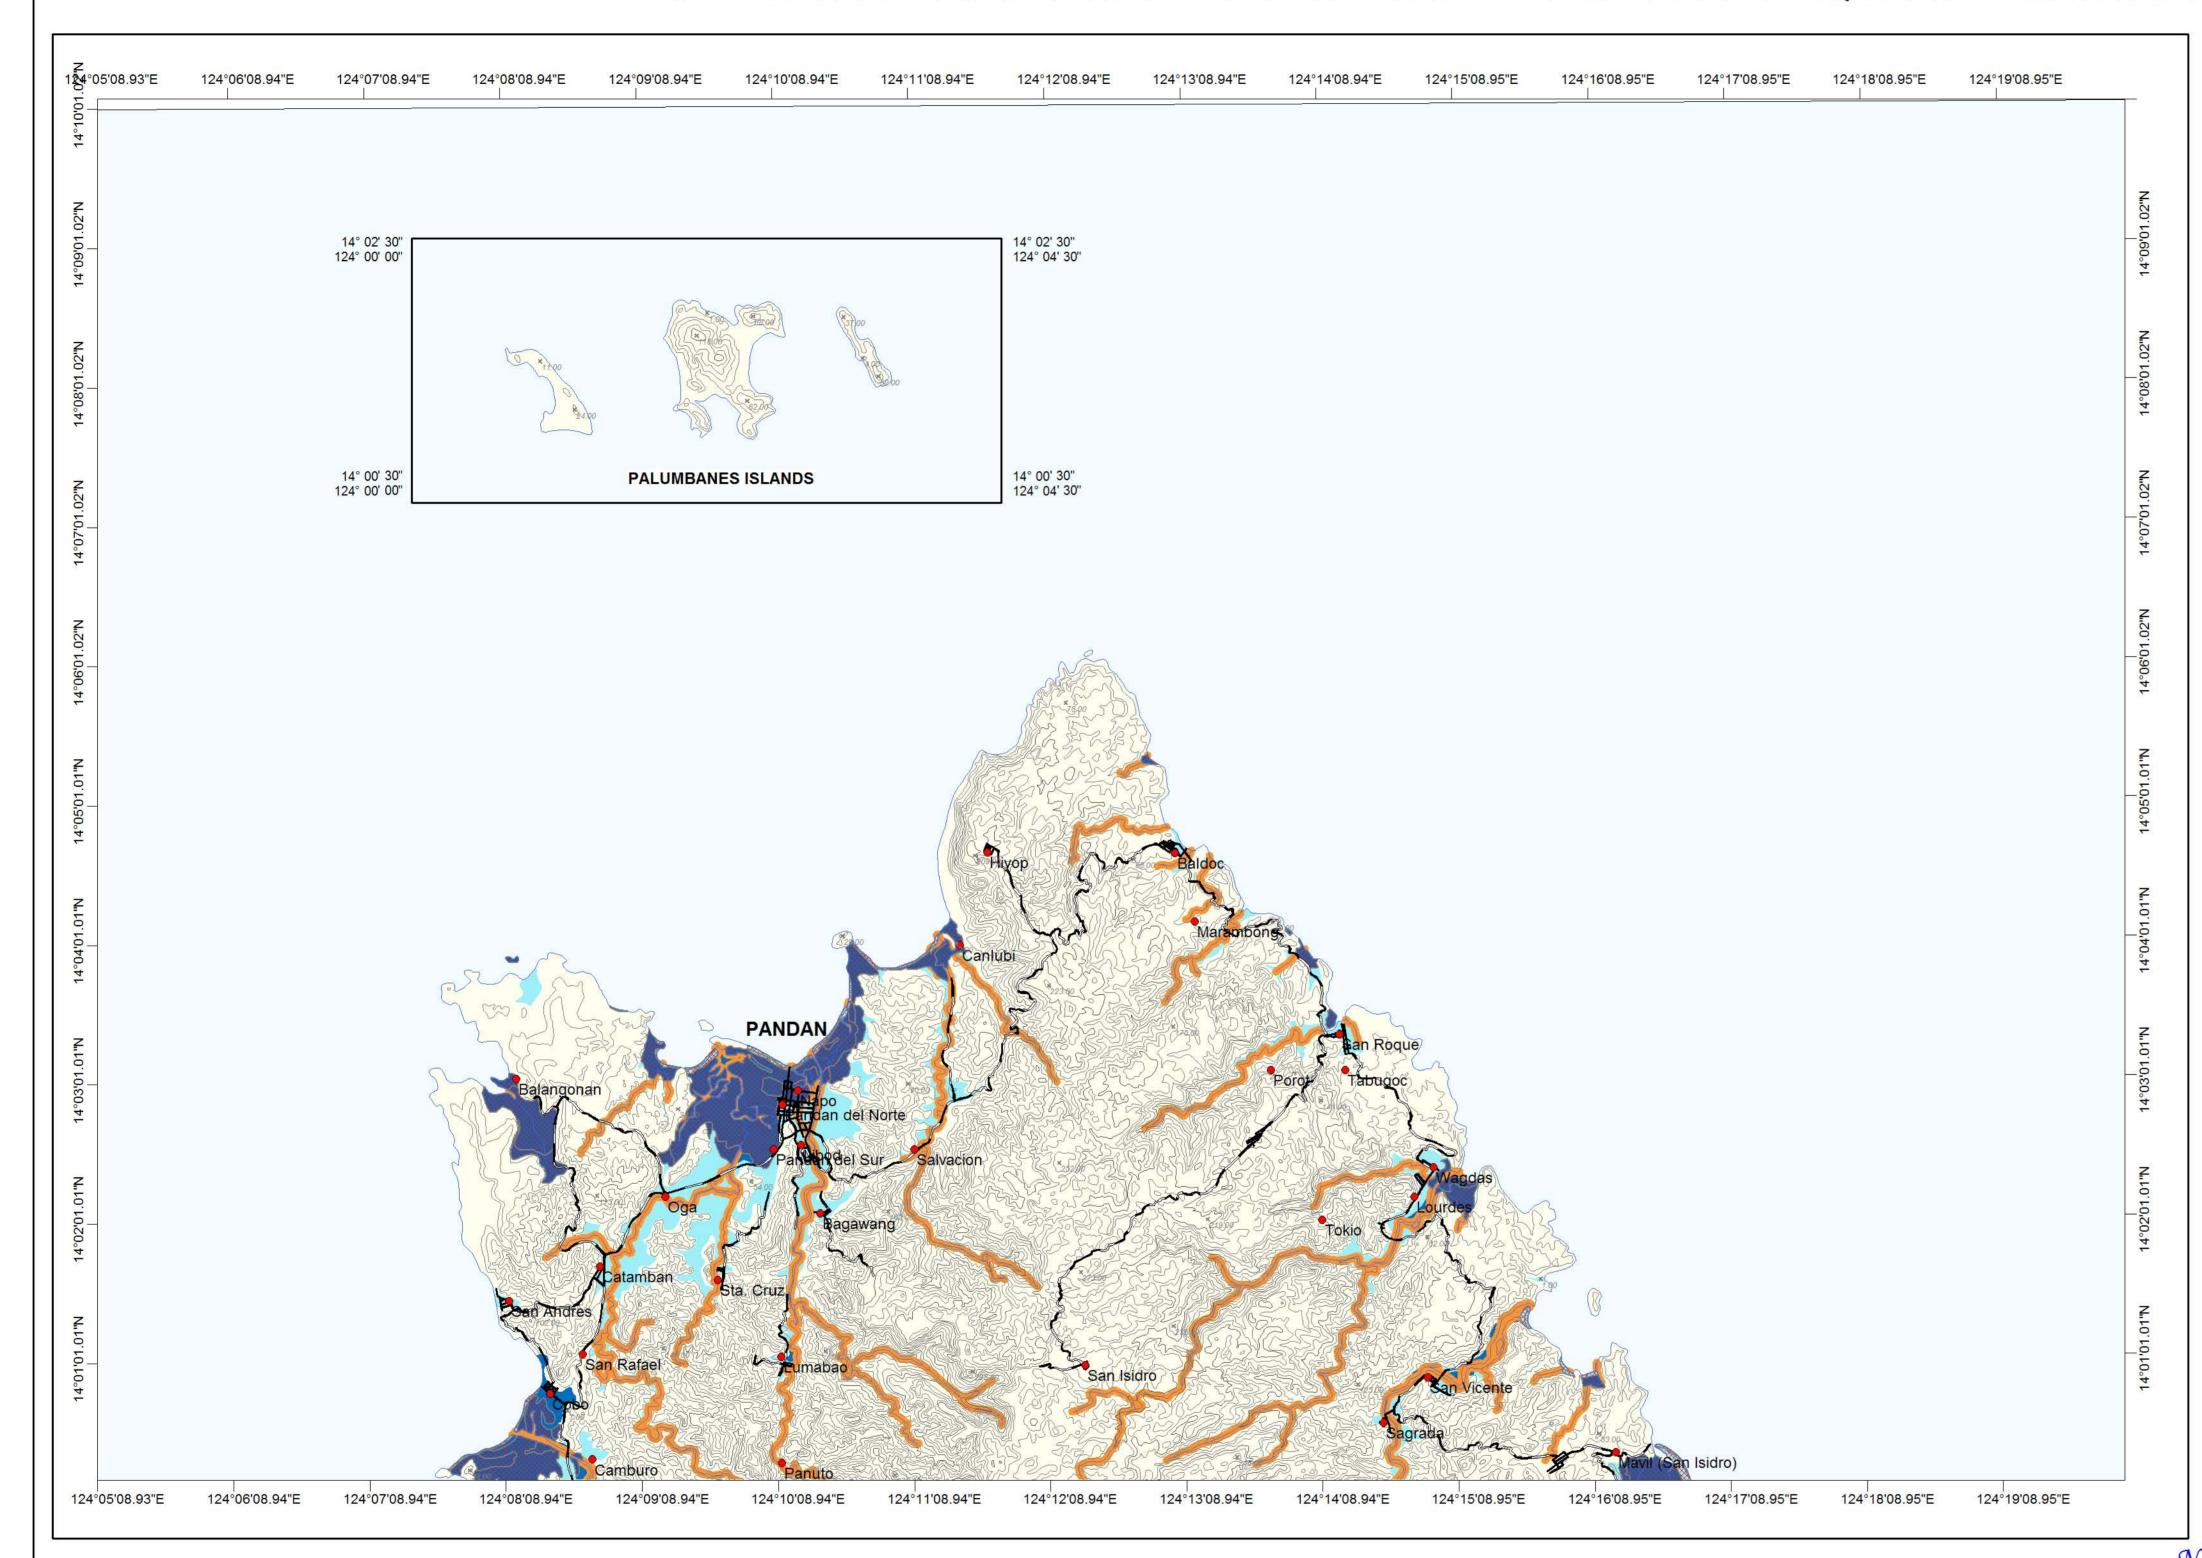
Flood hazard susceptibility zones were derived based on the geomorphological analysis of landforms and the fluvial system. Information on flood occurences, flood depths, duration of inundation as well as topographic information supported the geomorphologically-based flood hazard mapping.

Areas that are frequently flooded. Mere heavy rains of 1 to 2 days could bring about flooding in these areas. Moderate to strong typhoons could submerge these areas 1 to 3 meters or more in flood waters for a few days to a few weeks.

Areas that become inundated during moderate to strong typhoons. Flood depths vary from a few centimeters to 1 meter. Floods last from a few hours to a few days.

Areas with no reported flood occurences except along low lying areas immediately adjoining rivers or creeks.

Areas 0 to 50 meters from river banks of active river channels that are prone to bank erosion.
